Manhole Inspection Summary

Manhole # S29Q__004MH

Inspection ☐ Is Incomplete Rating: **3) Fair**

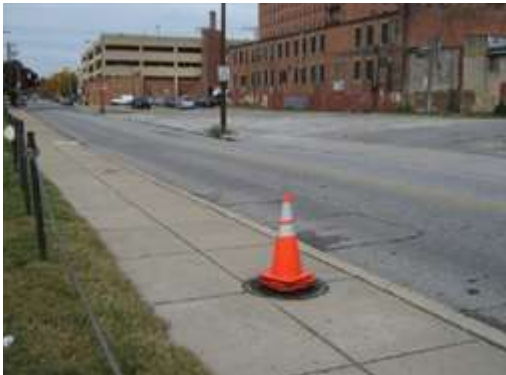
Location View

mh cover

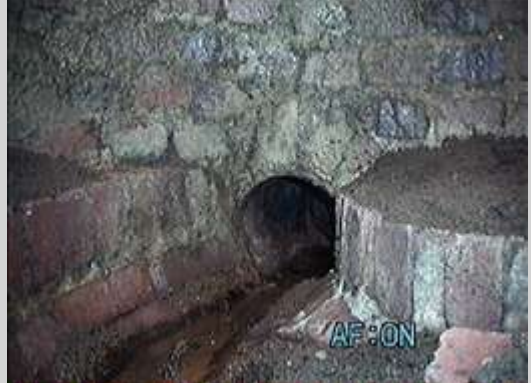
12 O'Clock Outflow

8 in. Circular Gravity Sewer
Pipe Out @ 12 O'Clock

Pipe Height: **8.4** (in.) Rod and Bar (Angled)

Pipe Material: **Clay** ☐ Pipe Lined

Invert Depth: **8.70** (ft.) Flow Characteristics: **Slow**

Infiltration: **None** Pipe Seal Cond: **Sound**

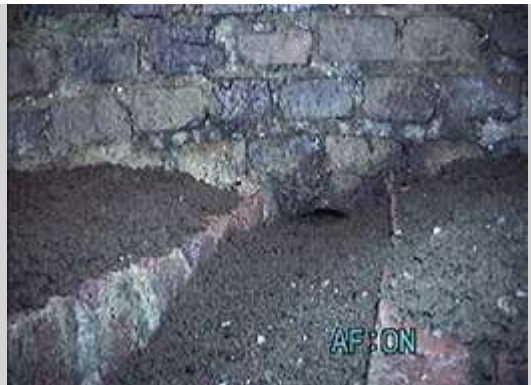
4 O'Clock Inflow

6 in. Circular Gravity Sewer
Pipe In @ 4 O'Clock

Pipe Material: **Clay** ☐ Pipe Lined

Invert Depth: **8.60** (ft.) Flow Characteristics: **None**

Connects To: **Stub connection / abandoned**

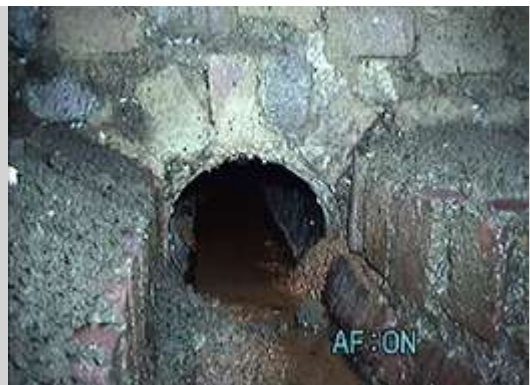
8 O'Clock Inflow

8 in. Circular Gravity Sewer
Pipe In @ 8 O'Clock

Pipe Height: **8.4** (in.) Rod and Bar (Angled)

Pipe Material: **Clay** ☐ Pipe Lined

Infiltration: **None**
